(NASA-TM-X-70381) EVALUATION OF GROUND
CHARACTERIZATION SAMPLES MCN-2 AND MCN-3,
SECTION 1 (NASA) 56 p HC \$6.00 CSCL 13H

SECTION I. EVALUATION OF GROUND CHARACTERIZATION
SAMPLES MCN-2 AND MCN-3

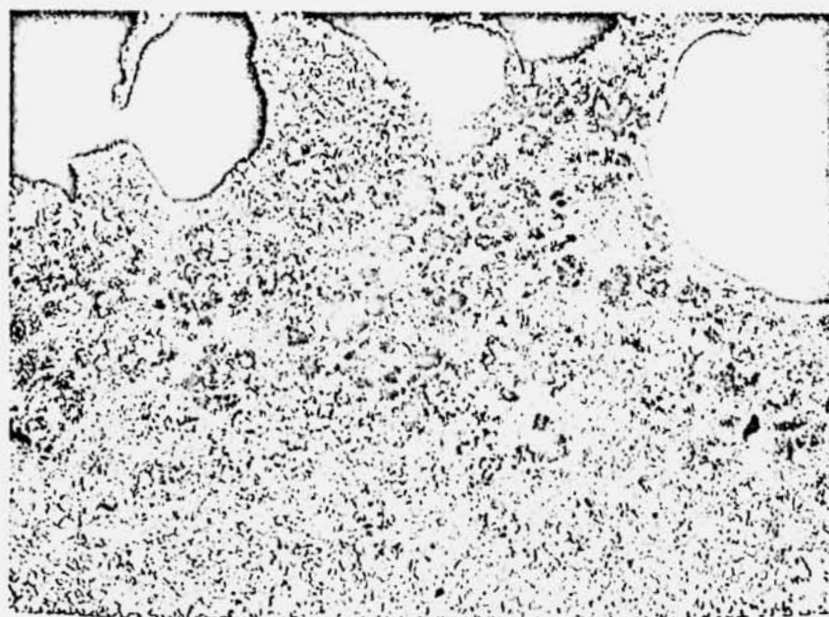
FIGURE II-19a. SECTION MCS-3-3

A section through the right-hand ring groove is shown at 4X in Figure II-19a. The ring groove is void; however, a thin film of filler metal was present on its surfaces. The surface roughness of the filler metal that accumulated inside the tube during brazing is clearly evident. An area of accumulated filler metal is shown at 100X in Figure II-19b. Voids or pores are present in this area. The microstructure of this area is somewhat different from that observed in similar sections from Samples MCS-1 and MCS-2. Although the maximum brazing temperature for Sample MCS-3 was less than it was for the other two samples, the products of the reaction between the base metal and the molten filler metal appear to be dispersed in larger amounts throughout the microstructure.
